Chingford Development Site, St Martin's Road, Nottingham

Ground Conditions Desk Study

Hydrock Ref: R/C-08250-C/001

Title: Ground Conditions Desk Study Report

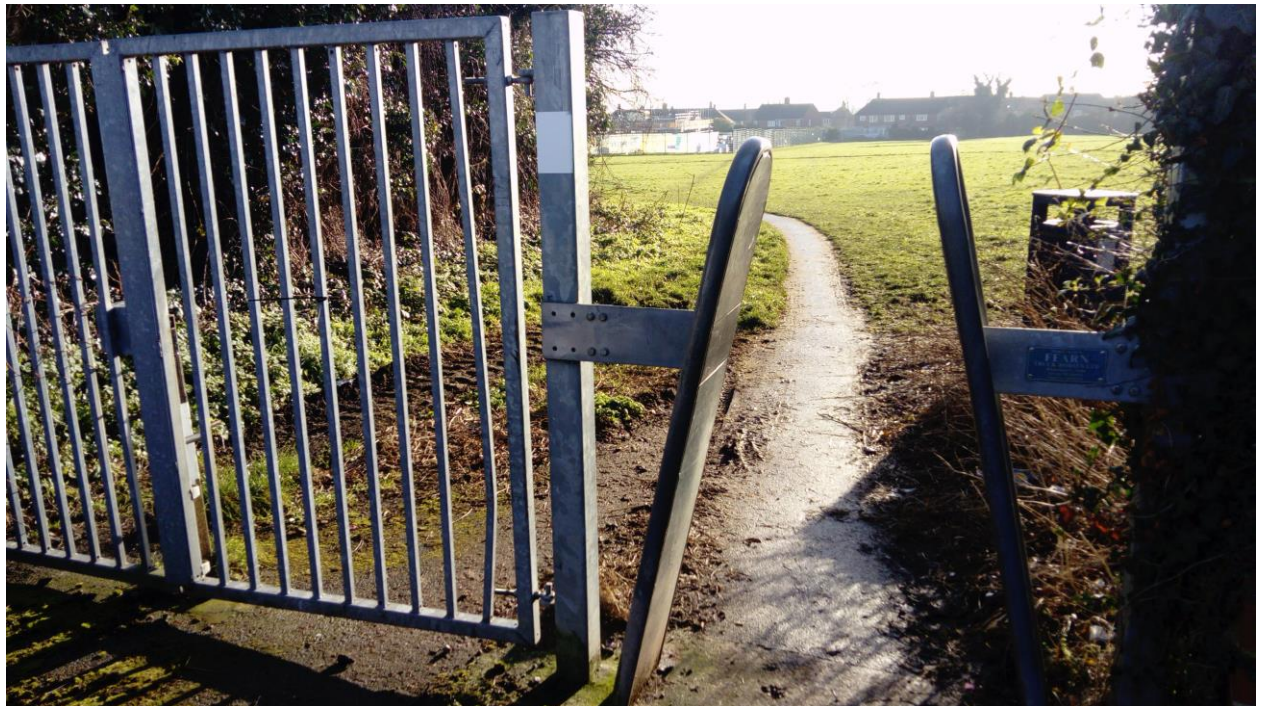
Plate 1: Site entrance.

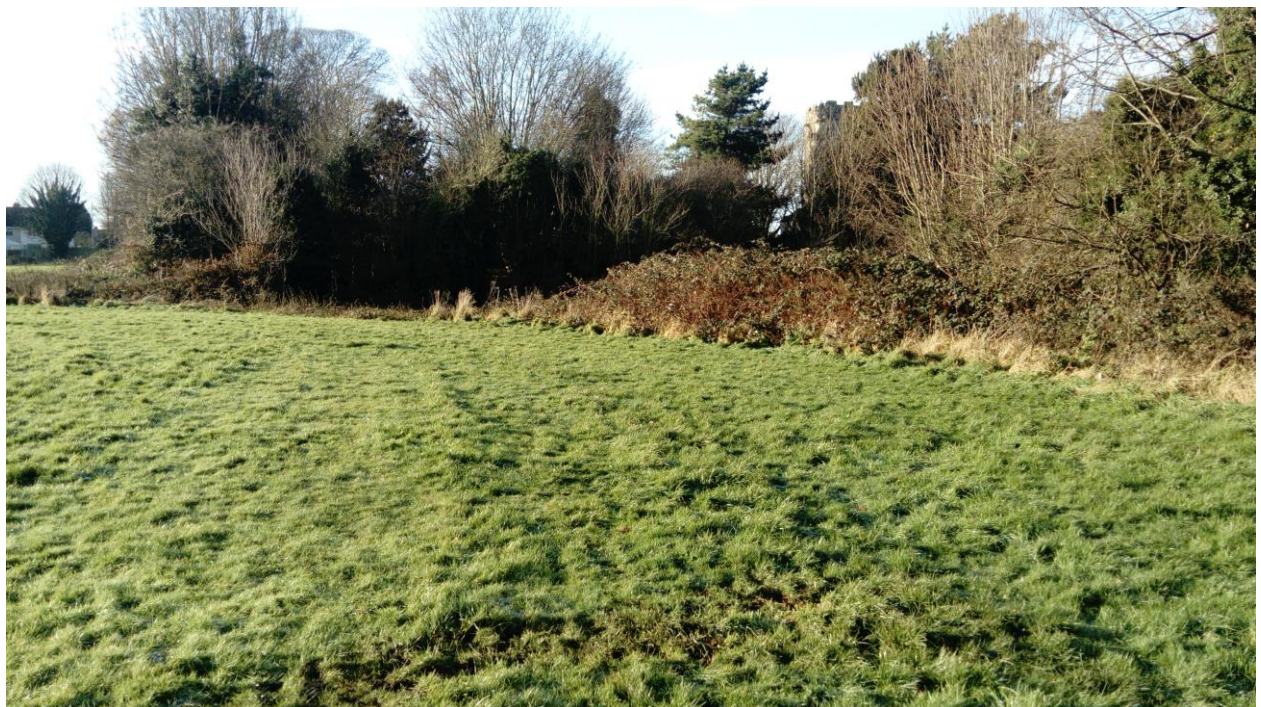
Plate 2: Looking towards overgrown area in the northwestern site boundary.

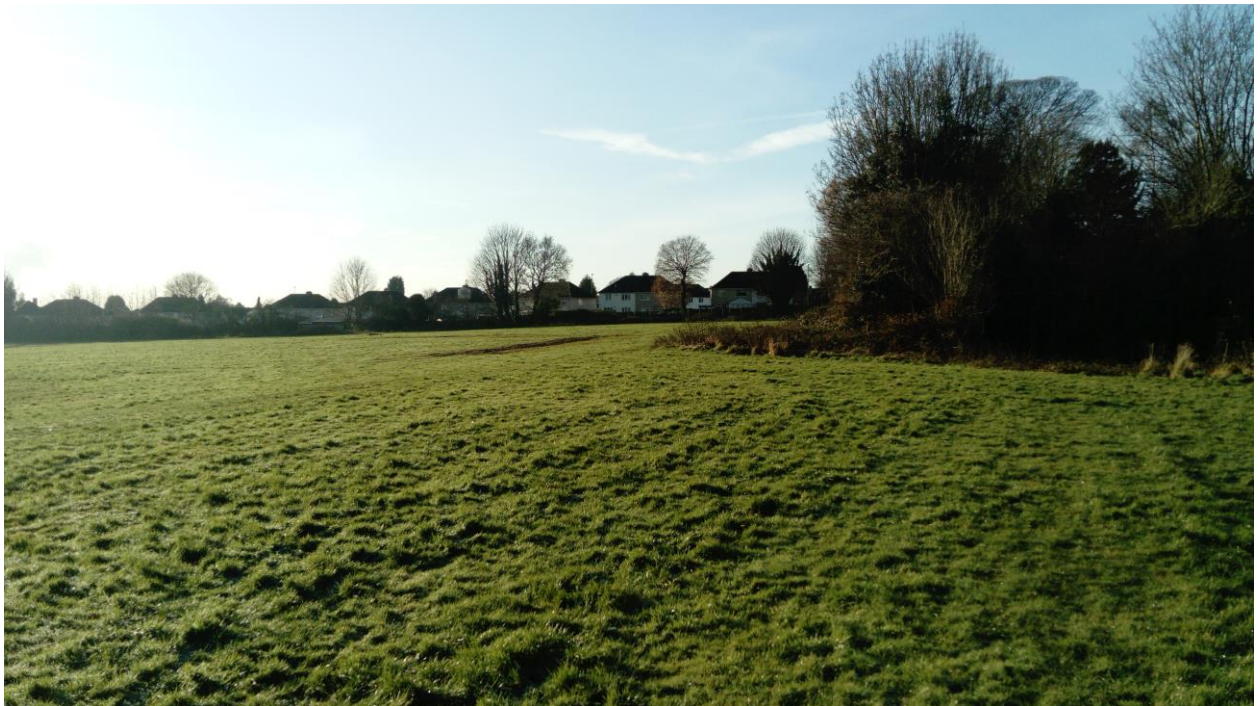
Plate General view of the site, looking towards the southwest.

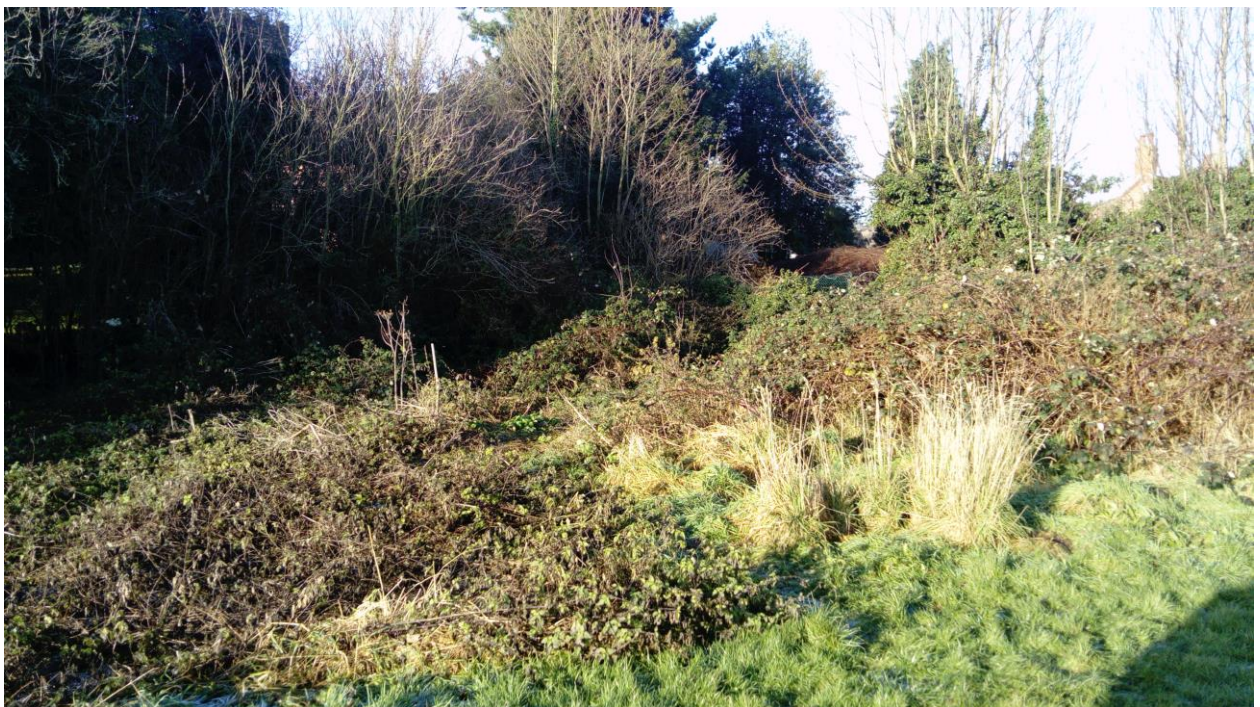
Plate 3: Undergrowth on the northern site perimeter.

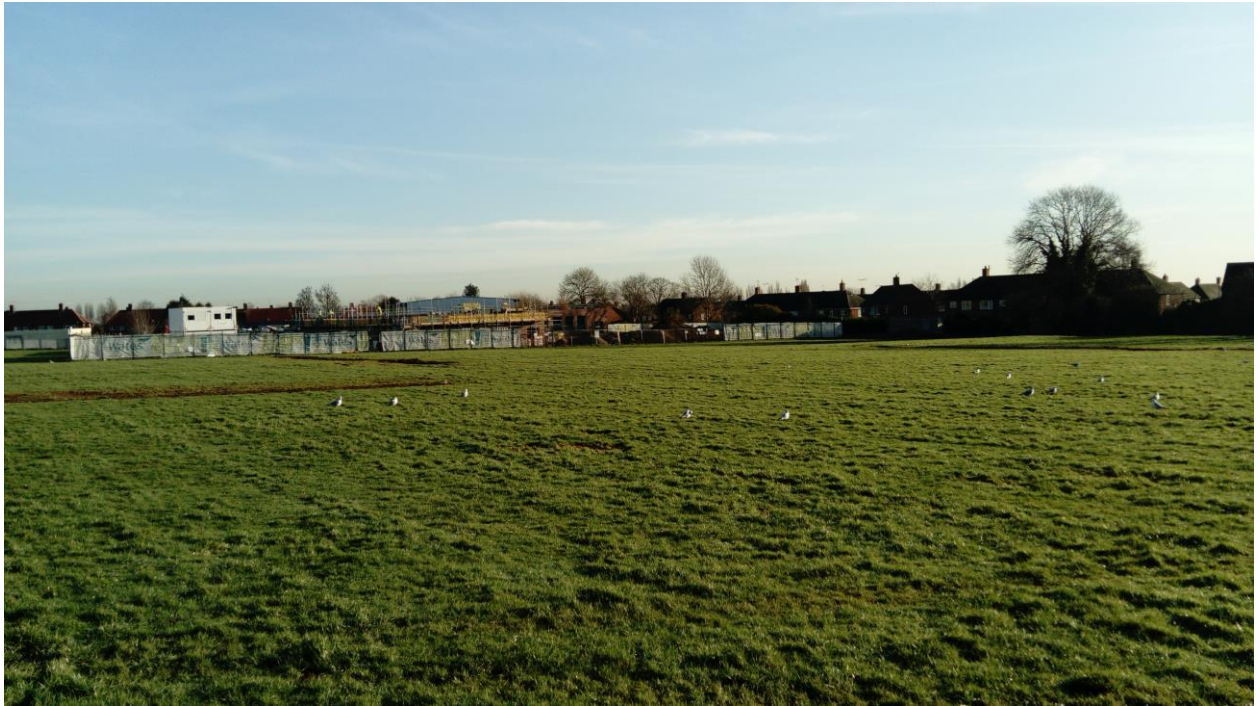
Plate 6: Looking east towards the school development.

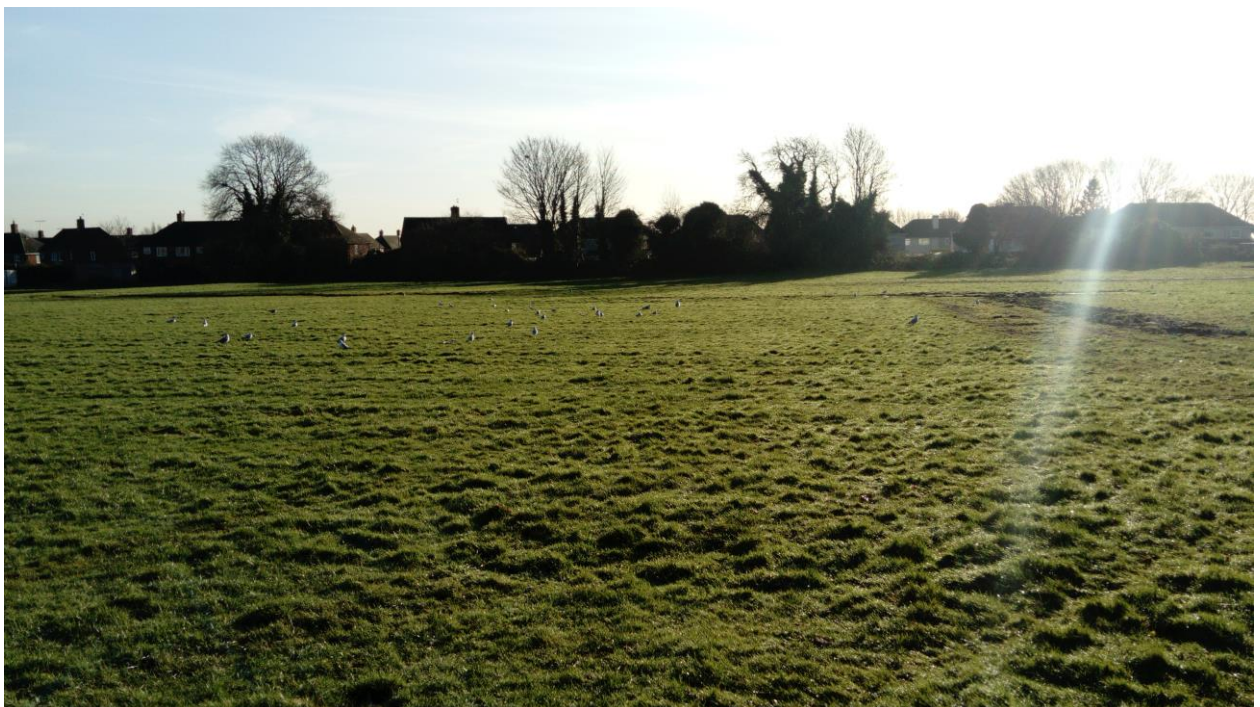
Plate 7: General view, looking towards the south.
